**HYDROGEN GAS PRESSURE VESSEL
PROBLEMS IN THE M-1 FACILITIES**

by J. S. Laws, V. Frick, and J. McConnell

Prepared by
AEROJET-GENERAL CORPORATION
Sacramento, Calif.
for Lewis Research Center

NATIONAL AERONAUTICS AND SPACE ADMINISTRATION • WASHINGTON, D. C. • MARCH 1969

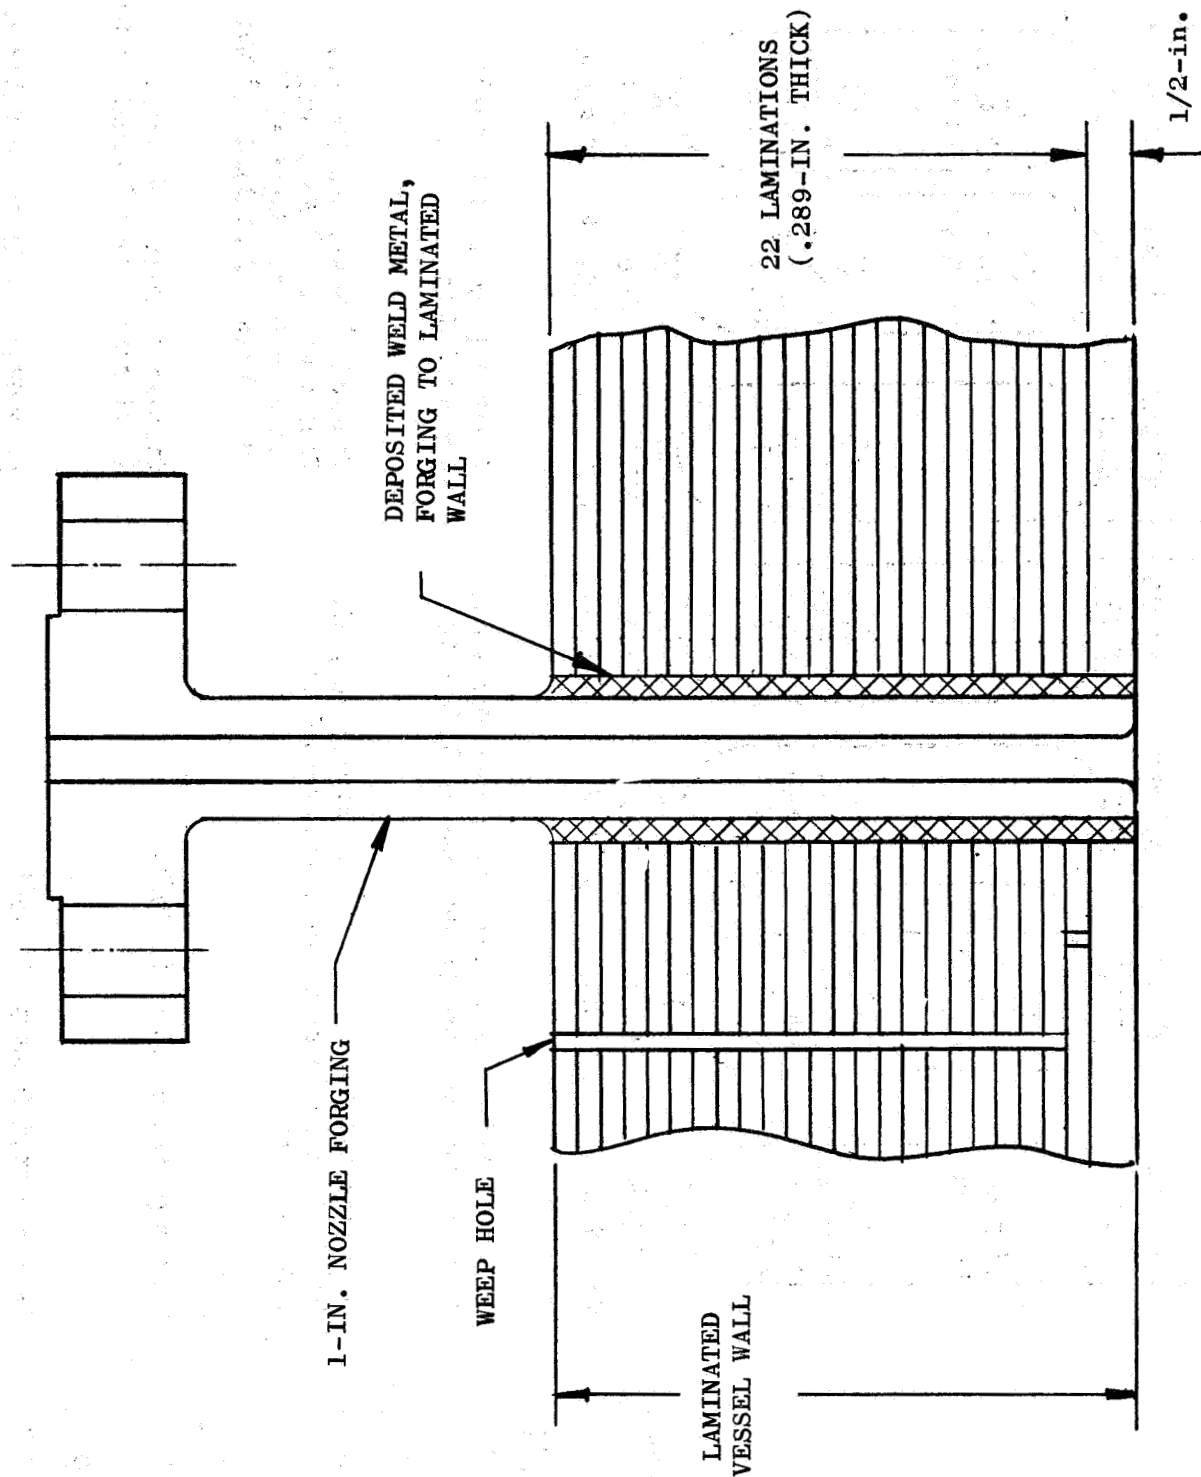
Figure 3

The 1-in. inside diameter x 2-1/4-in. outside diameter nozzles are inserted through a 4-1/4-in. diameter hole machined through the 23 layers which make up the vessel shell (see Figure No. 3). The joint design consists of a 1-in. wide, straight-sided circumferential joint around the nozzle. The joint is manually-welded from the inside of the vessel with a SW 120A electrode. No stress relief is applied to this weld. The 8-in. and 4-in., or 16-in. manways are manually-welded into the hemispherical heads and stress-relieved at 1150°F for four and three-quarter hours. Then, the heads are welded to the cylindrical shell to complete the assembly. The tanks are required to pass a 7500 psi hydrostatic proof test.

The latest leak occurred on 11 January 1965 in vessel VH-74 after approximately five months of service. This vessel was pressurized to 4600 psi with gaseous hydrogen and had been holding the pressure for 72 hours prior to failure. Again, the leak was associated with the 1-in. nozzle. When this failure occurred, the Test Division requested assistance from Liquid Rocket Operations Materials Engineering to determine the possible cause of the vessel failures. This report presents the failure analysis investigation conducted on a portion of the failed nozzle and weld. The remaining portion of the nozzle and weld was submitted to the A. O. Smith Corp. for an independent analysis.

1-in. Nozzle Cross-Section, A.O. Smith 1300 cu. ft. Receiver

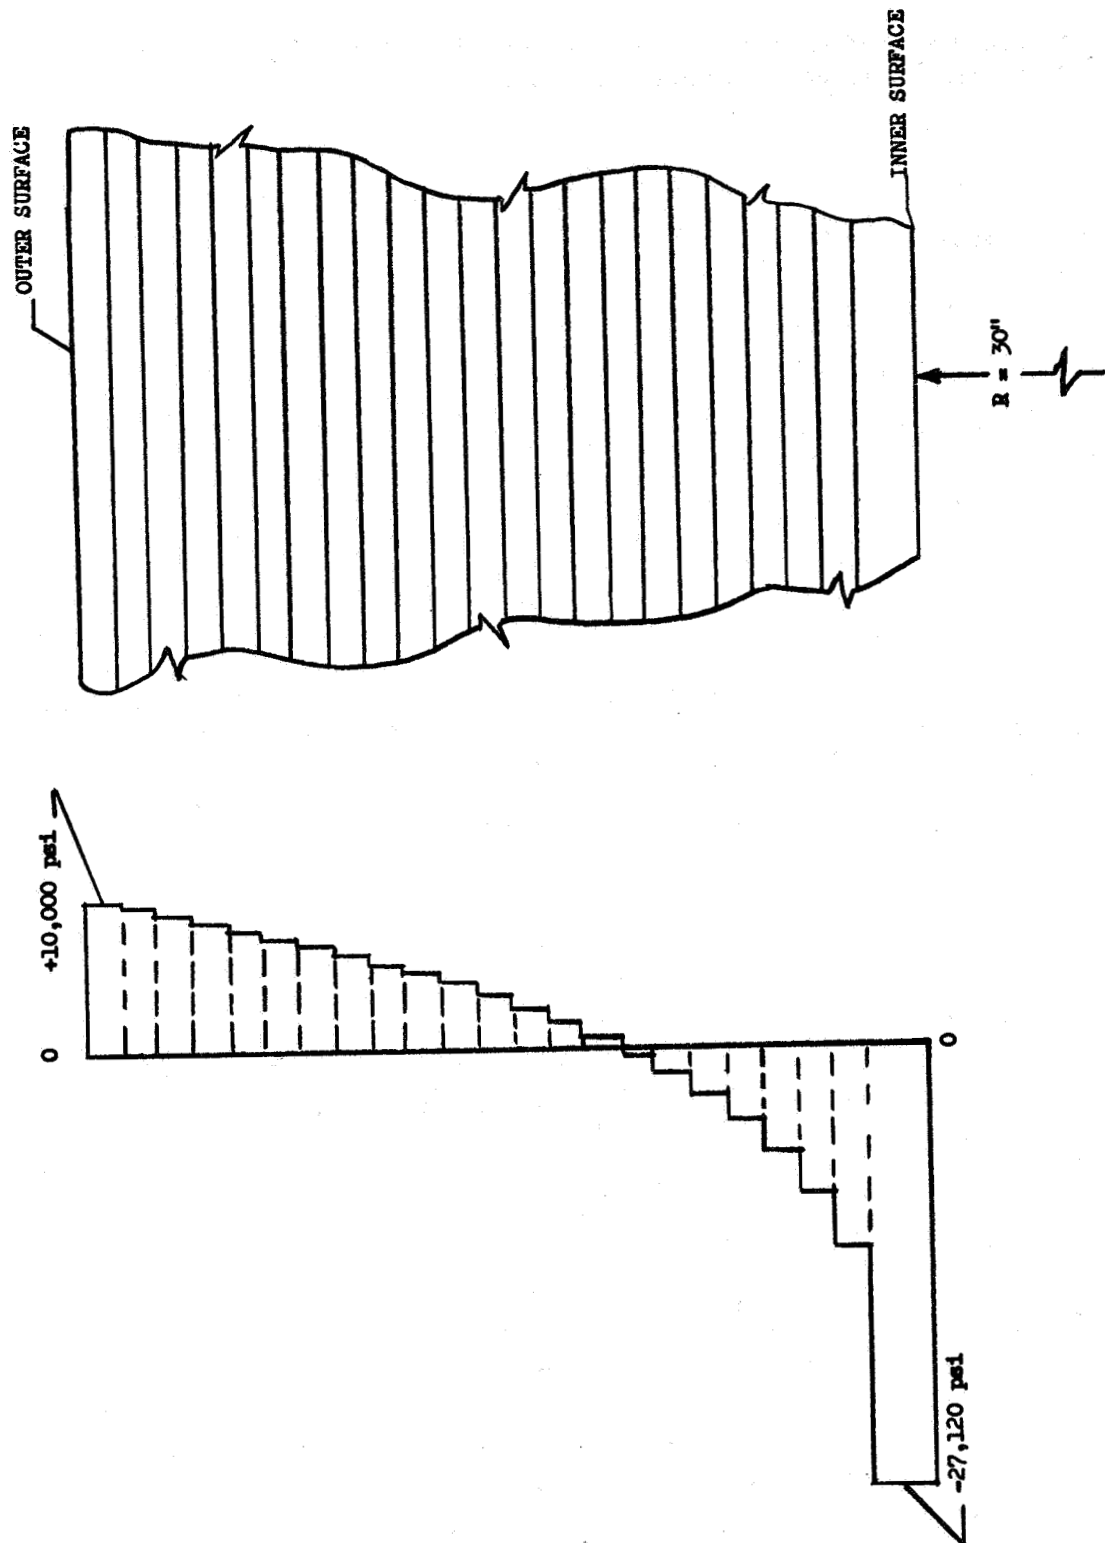
Figure 20: Hoop Stress Distribution Attributable to Pre-load Operation in Manufacture

The above expression has been evaluated for all layers and a plot of the final pre-stress as a function of radial locations is shown on Figure No. 20. From this plot, it is seen that the pre-compression reaches a maximum of approximately 27,000 psi at the inner surface of the shell.

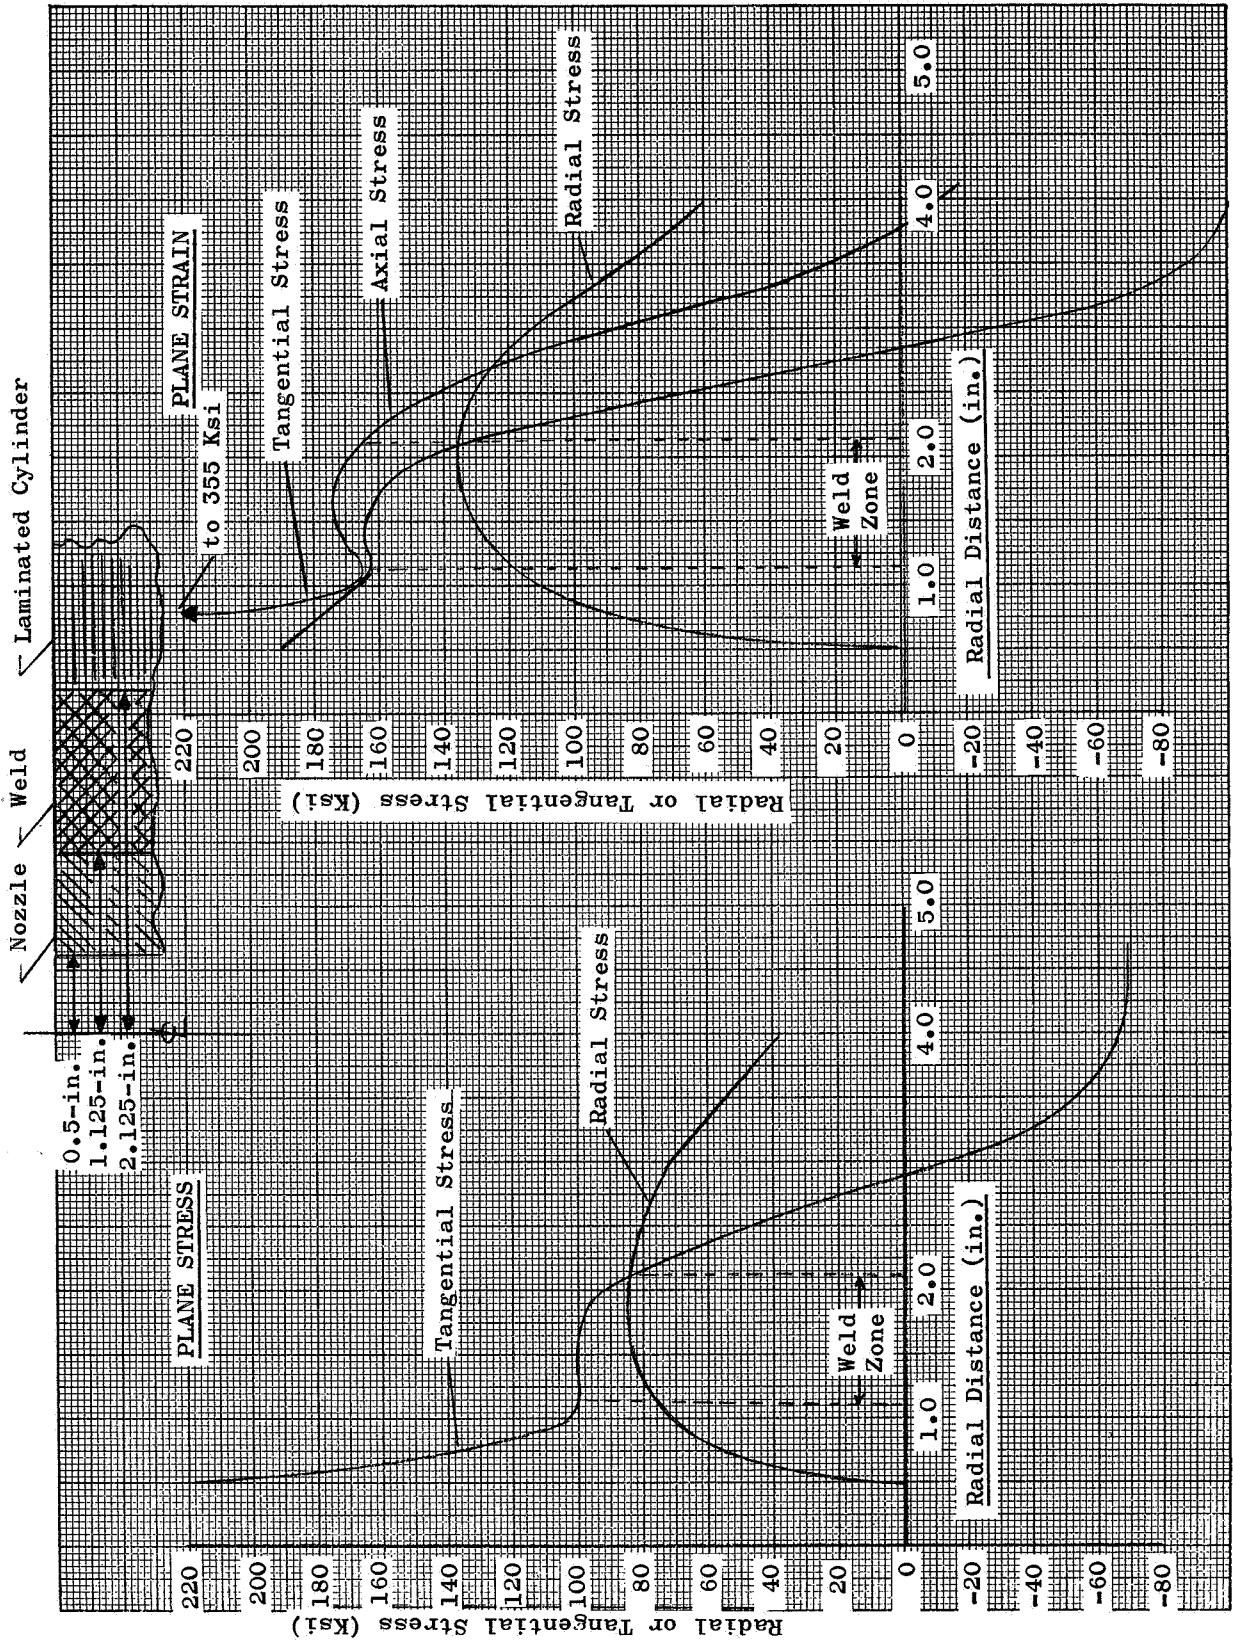
Figure 21: Stress Distribution Radially-Outward from Nozzle Centerline

Plots of the tangential stress distribution in the basic cylinder for each of the above conditions are shown on Figure No. 21. In the vicinity of the 1-in. nozzle, the stress distribution in the basic cylinder will be modified by the presence of the hole. For a 2:1 biaxial stress field, such as exists in cylindrical pressure vessels, the tangential stress at the edge of the hole is increased over the nominal stress by a factor of 2-1/2. This would result in the stress distribution shown on Figure No. 22 being multiplied by 2-1/2 to obtain the maximum values at the inside edge of the nozzle opening.

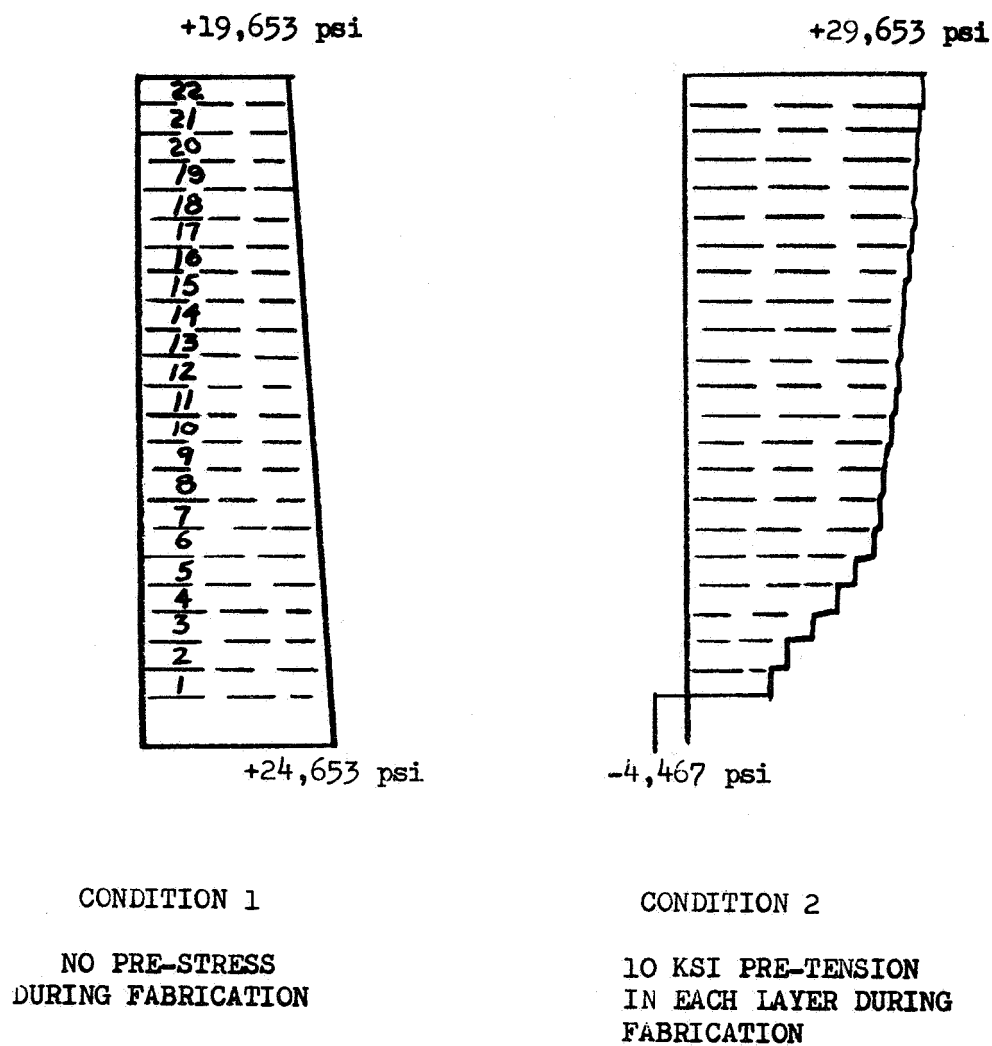
Figure 22: Hoop Stress Distribution Through Thickness of Cylinder

the maximum applied strain at this point would be between -0.9% and +0.78%. Considering the worst possibility, the maximum tangential strain at the edge of the nozzle opening would be 1.39%, with 0.78% of this being of a cyclic nature. Normally, this condition, while undesirable, is apparently not too serious for a material having approximately a 25% elongation.

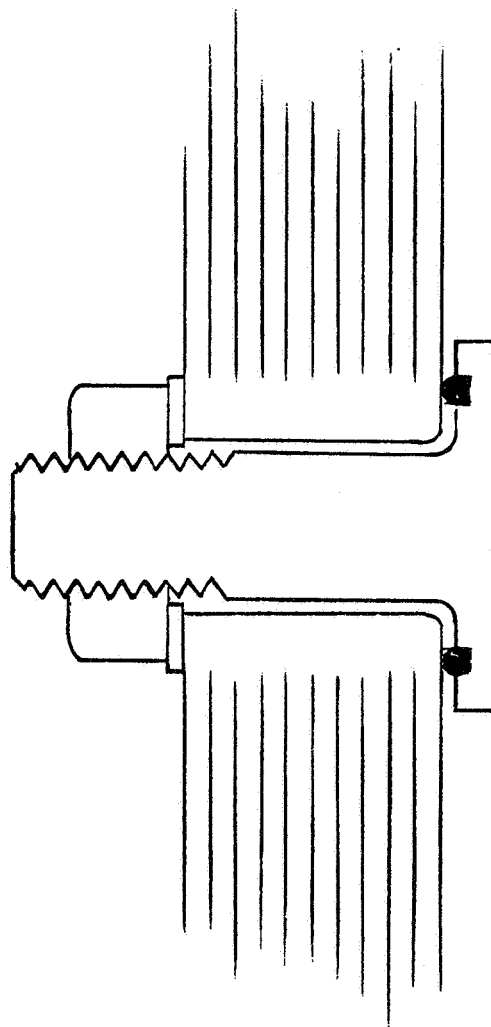
Figure 24: Tension Plug, Static Seal Replacement

1. Requires Static Seal at Curved Inner Surface with Doubtful Performance, or Machined Flat Surface with Discontinuity to Inner Lamination.

b. Remove 1-in. nozzles and close the opening with a mechanical plug incorporating a static seal (Figure No. 24).

1. Relatively Economical.
2. Removes Residual Stress (Stress Riser Areas from High-Pressure Hydrogen Exposure.
